YOUR ONESURVEY
HOME REPORT

33 Broomhill Drive
Glasgow
G11 7AB

SINGLE SURVEY

Prepared by	Grant Robertson, FRICS Glasgow North - Allied Surveyors Scotland Plc
--------------------	-------------------------------------------------------------------------

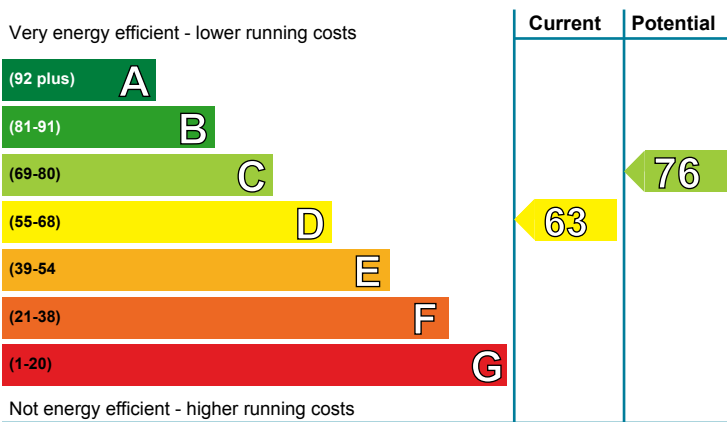
Energy Efficiency Rating

Your current rating is **band D (63)**. The average rating for EPCs in Scotland is **band D (61)**.
