# Home Report

## 3 Lochaber Crescent Kinlochleven PH50 4QS

Inspected on: 13<sup>th</sup> February 2018

**Prepared by:**  
Samuel & Partners  
First Surveyors Scotland  
44 High Street  
FORT WILLIAM  
PH33 6AH

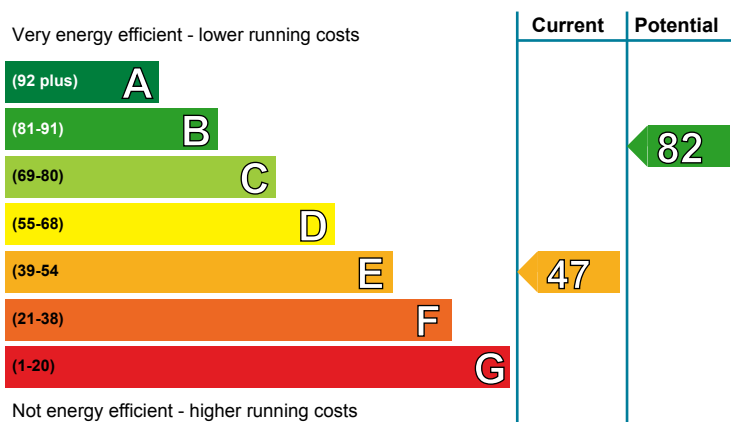
## Energy Efficiency Rating

This graph shows the current efficiency of your home, taking into account both energy efficiency and fuel costs. The higher this rating, the lower your fuel bills are likely to be.

Your current rating is **band E (47)**. The average rating for EPCs in Scotland is **band D (61)**.

The potential rating shows the effect of undertaking all of the improvement measures listed within your recommendations report.

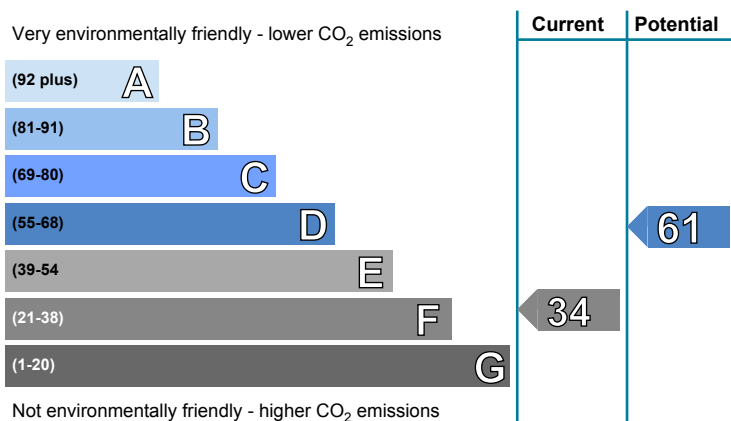
## Environmental Impact (CO<sub>2</sub>) Rating

This graph shows the effect of your home on the environment in terms of carbon dioxide (CO<sub>2</sub>) emissions. The higher the rating, the less impact it has on the environment.
