Home Report

20 Letham Drive Glasgow G43 2SL

survey report on:

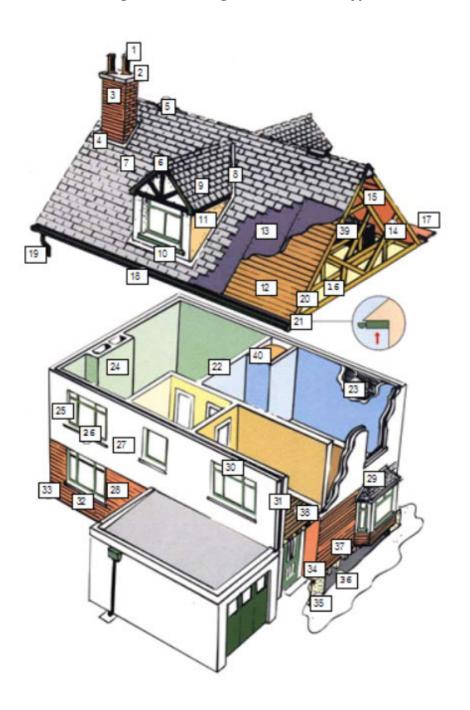
Sectional Diagram showing elements of a typical house

1	Chimney pots			
2	Coping stone			
3	Chimney head			
4	Flashing			
5	Ridge ventilation			
6	Ridge board			
7	Slates/tiles			
8	Valley guttering			
9	Dormer projection			
10	Dormer flashing			
11	Dormer cheeks			
12	Sarking			
13	Roof felt			
14	Trusses			
15	Collar			
16	Insulation			
17	Parapet gutter			
18	Eaves guttering			
19	Rainwater downpipe			
20	Verge boards / skews			
21	Soffit boards			
22	Partition wall			
23	Lath / plaster			
24	Chimney breast			
25	Window pointing			
26	Window sills			
27	Rendering			
28	Brickwork / pointing			
29	Bay window			
	projection			
30	Lintels			
31	Cavity walls / wall ties			
32	Subfloor ventilator			
33	Damp proof course			
34	Base course
