YOUR ONESURVEY
HOME REPORT

Top floor
2 Botanic Crescent
Glasgow
G20 8QQ

HOME REPORT

Single Survey

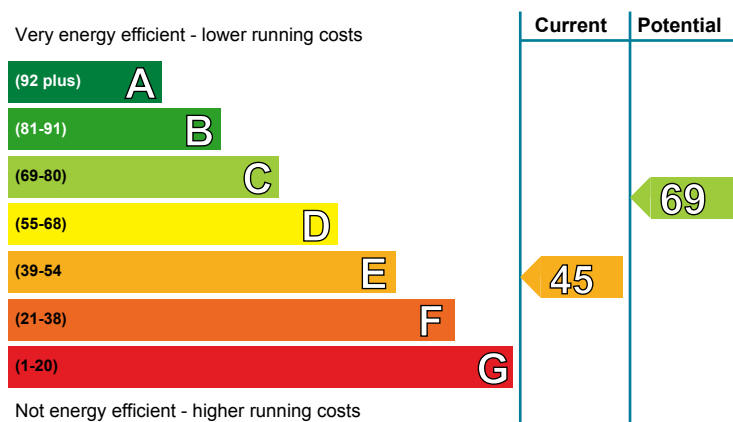
Energy Efficiency Rating

This graph shows the current efficiency of your home, taking into account both energy efficiency and fuel costs. The higher this rating, the lower your fuel bills are likely to be.

Your current rating is **band E (45)**. The average rating for EPCs in Scotland is **band D (61)**.

The potential rating shows the effect of undertaking all of the improvement measures listed within your recommendations report.
