YOUR ONESURVEY  
**HOME REPORT**

Heimdal  
3 Balfleurs Street  
Milngavie, Glasgow  
G62 8HW

# SINGLE SURVEY

A report on the condition of the property, with categories  
being rated from 1 to 3.

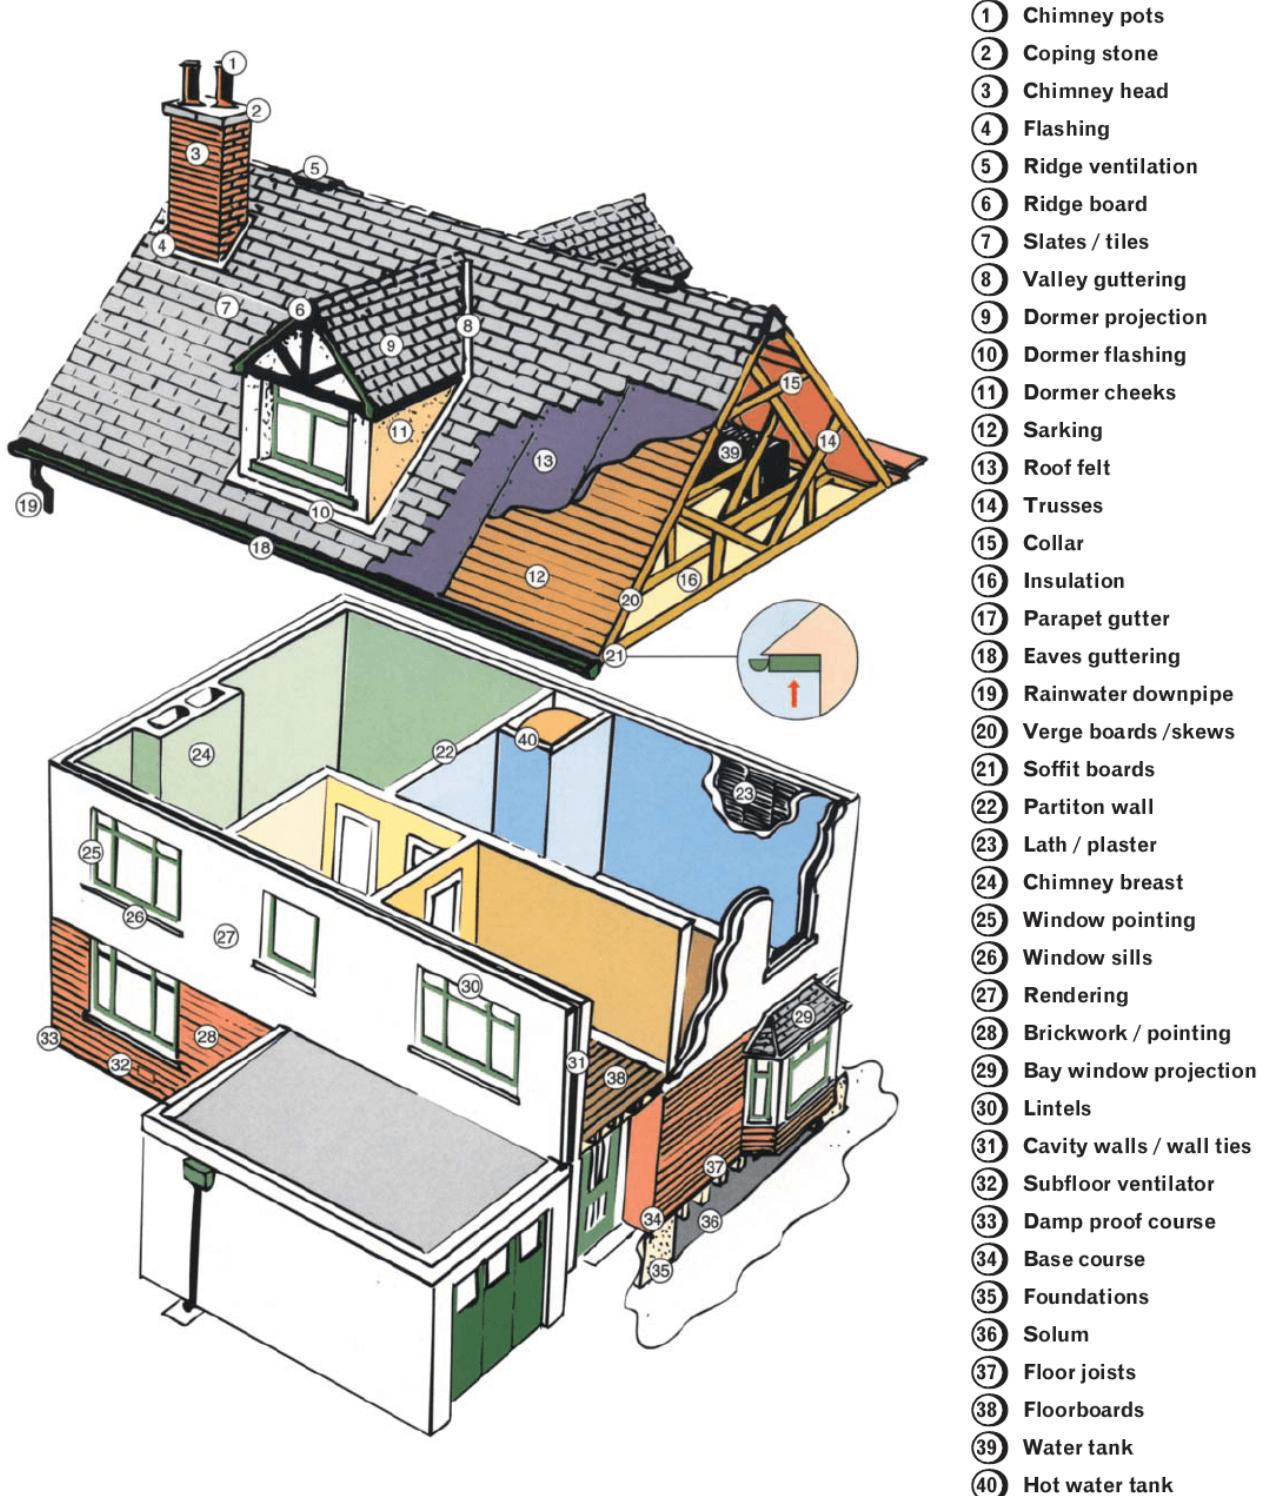
## Sectional Diagram showing elements of a typical house

Reference may be made in this report to some or all of the above component parts of the property. This diagram may assist you in locating and understanding these items.

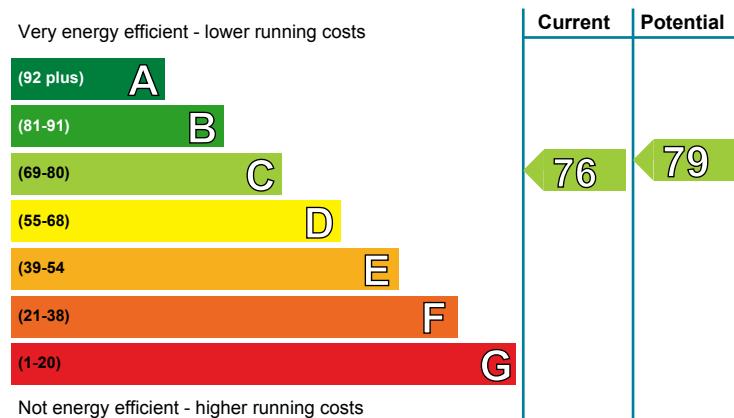
## Energy Efficiency Rating

This graph shows the current efficiency of your home, taking into account both energy efficiency and fuel costs. The higher this rating, the lower your fuel bills are likely to be.

Your current rating is **band C (76)**. The average rating for EPCs in Scotland is **band D (61)**.

The potential rating shows the effect of undertaking all of the improvement measures listed within your recommendations report.

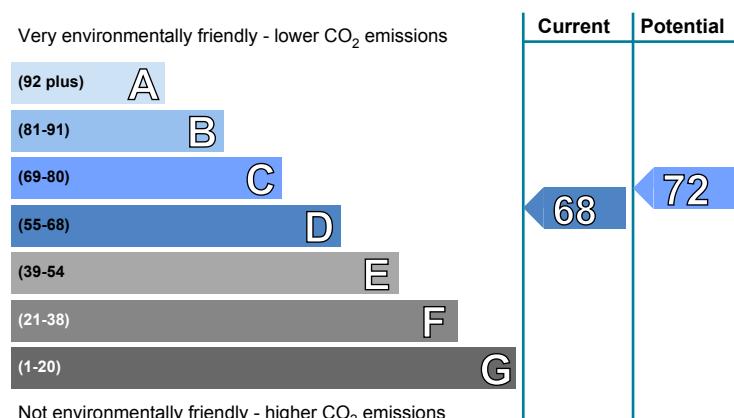
## Environmental Impact (CO<sub>2</sub>) Rating

This graph shows the effect of your home on the environment in terms of carbon dioxide (CO<sub>2</sub>) emissions. The higher the rating, the less impact it has on the environment.
