Home Report

1/2
1095 Pollokshaws Road
Glasgow
G41 3YG

single survey

Property address	1/2 1095 Pollokshaws Road Glasgow G41 3YG
Customer	Mr John Devine
Prepared by	David Hyde, MRICS

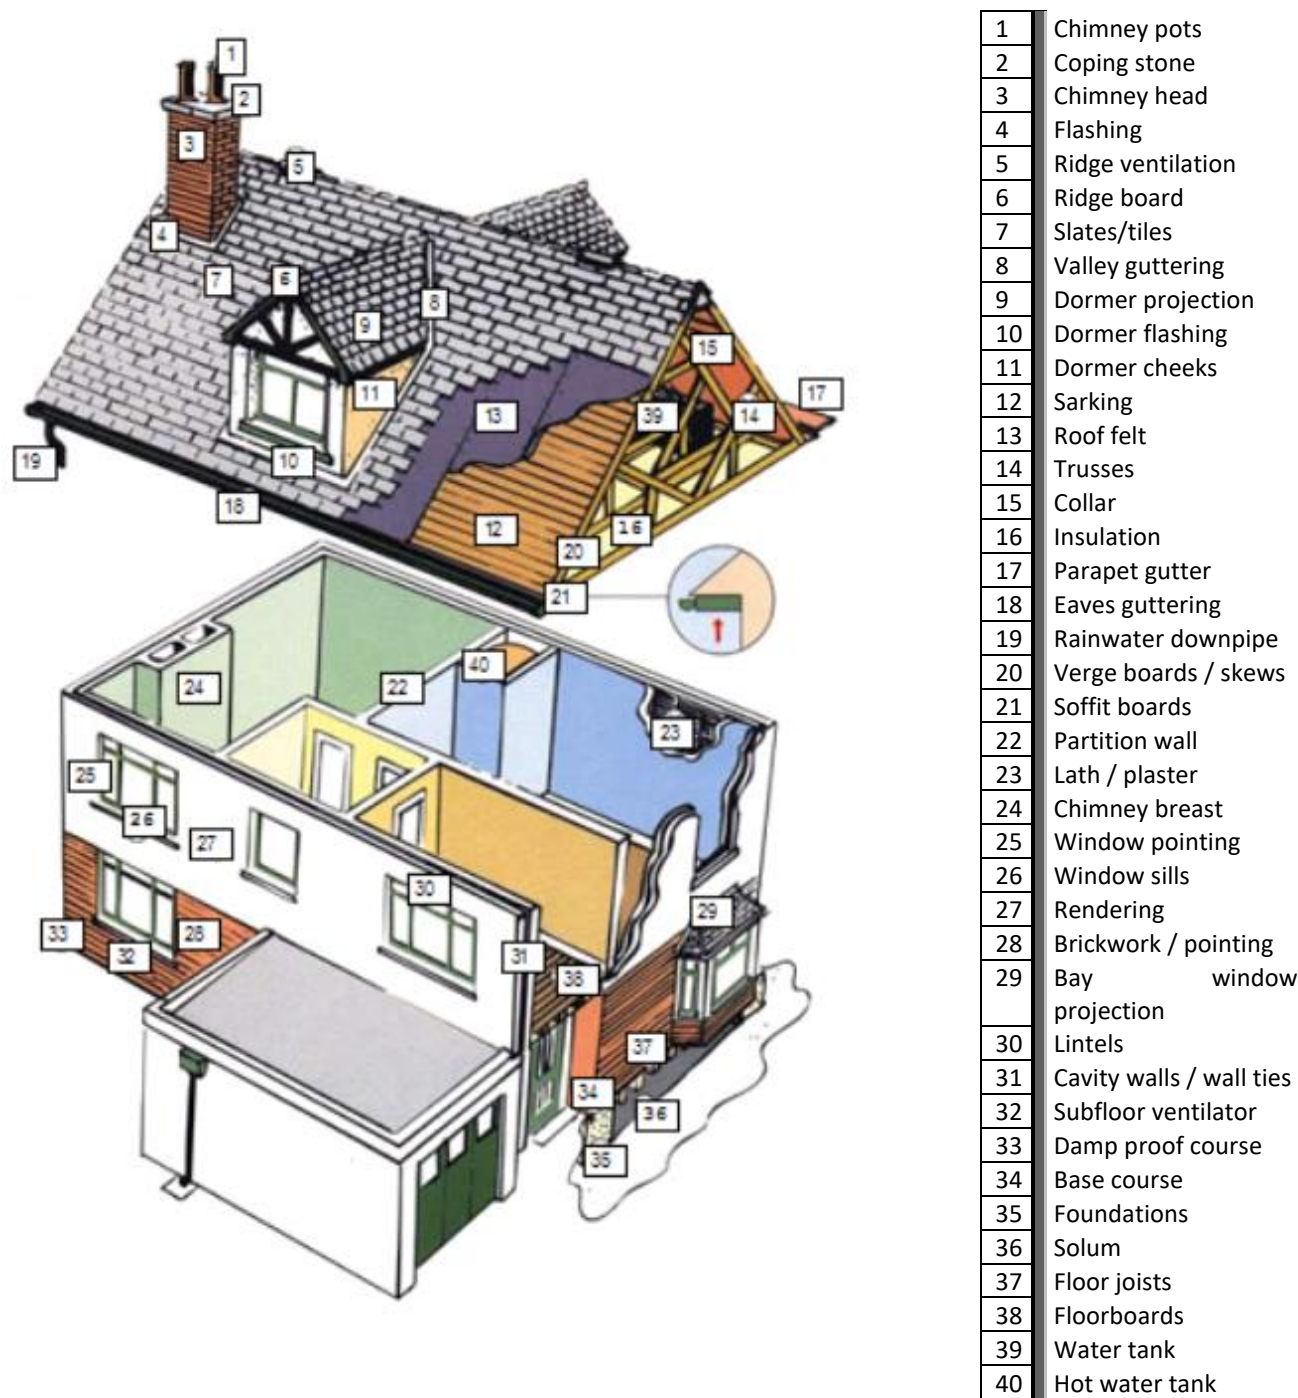
Sectional Diagram showing elements of a typical house

Reference may be made in this report to some or all of the above component parts of the property. This diagram may assist you in locating and understanding these items.
